VISUAL SITE INSPECTION REPORT – 2016

HOOSIER ENERGY REC
MEROM GENERATING STATION
AREA 3 RESTRICTED WASTE LANDFILL
MEROM, INDIANA

ATC PROJECT NO. 170LF00320

JANUARY 18, 2017

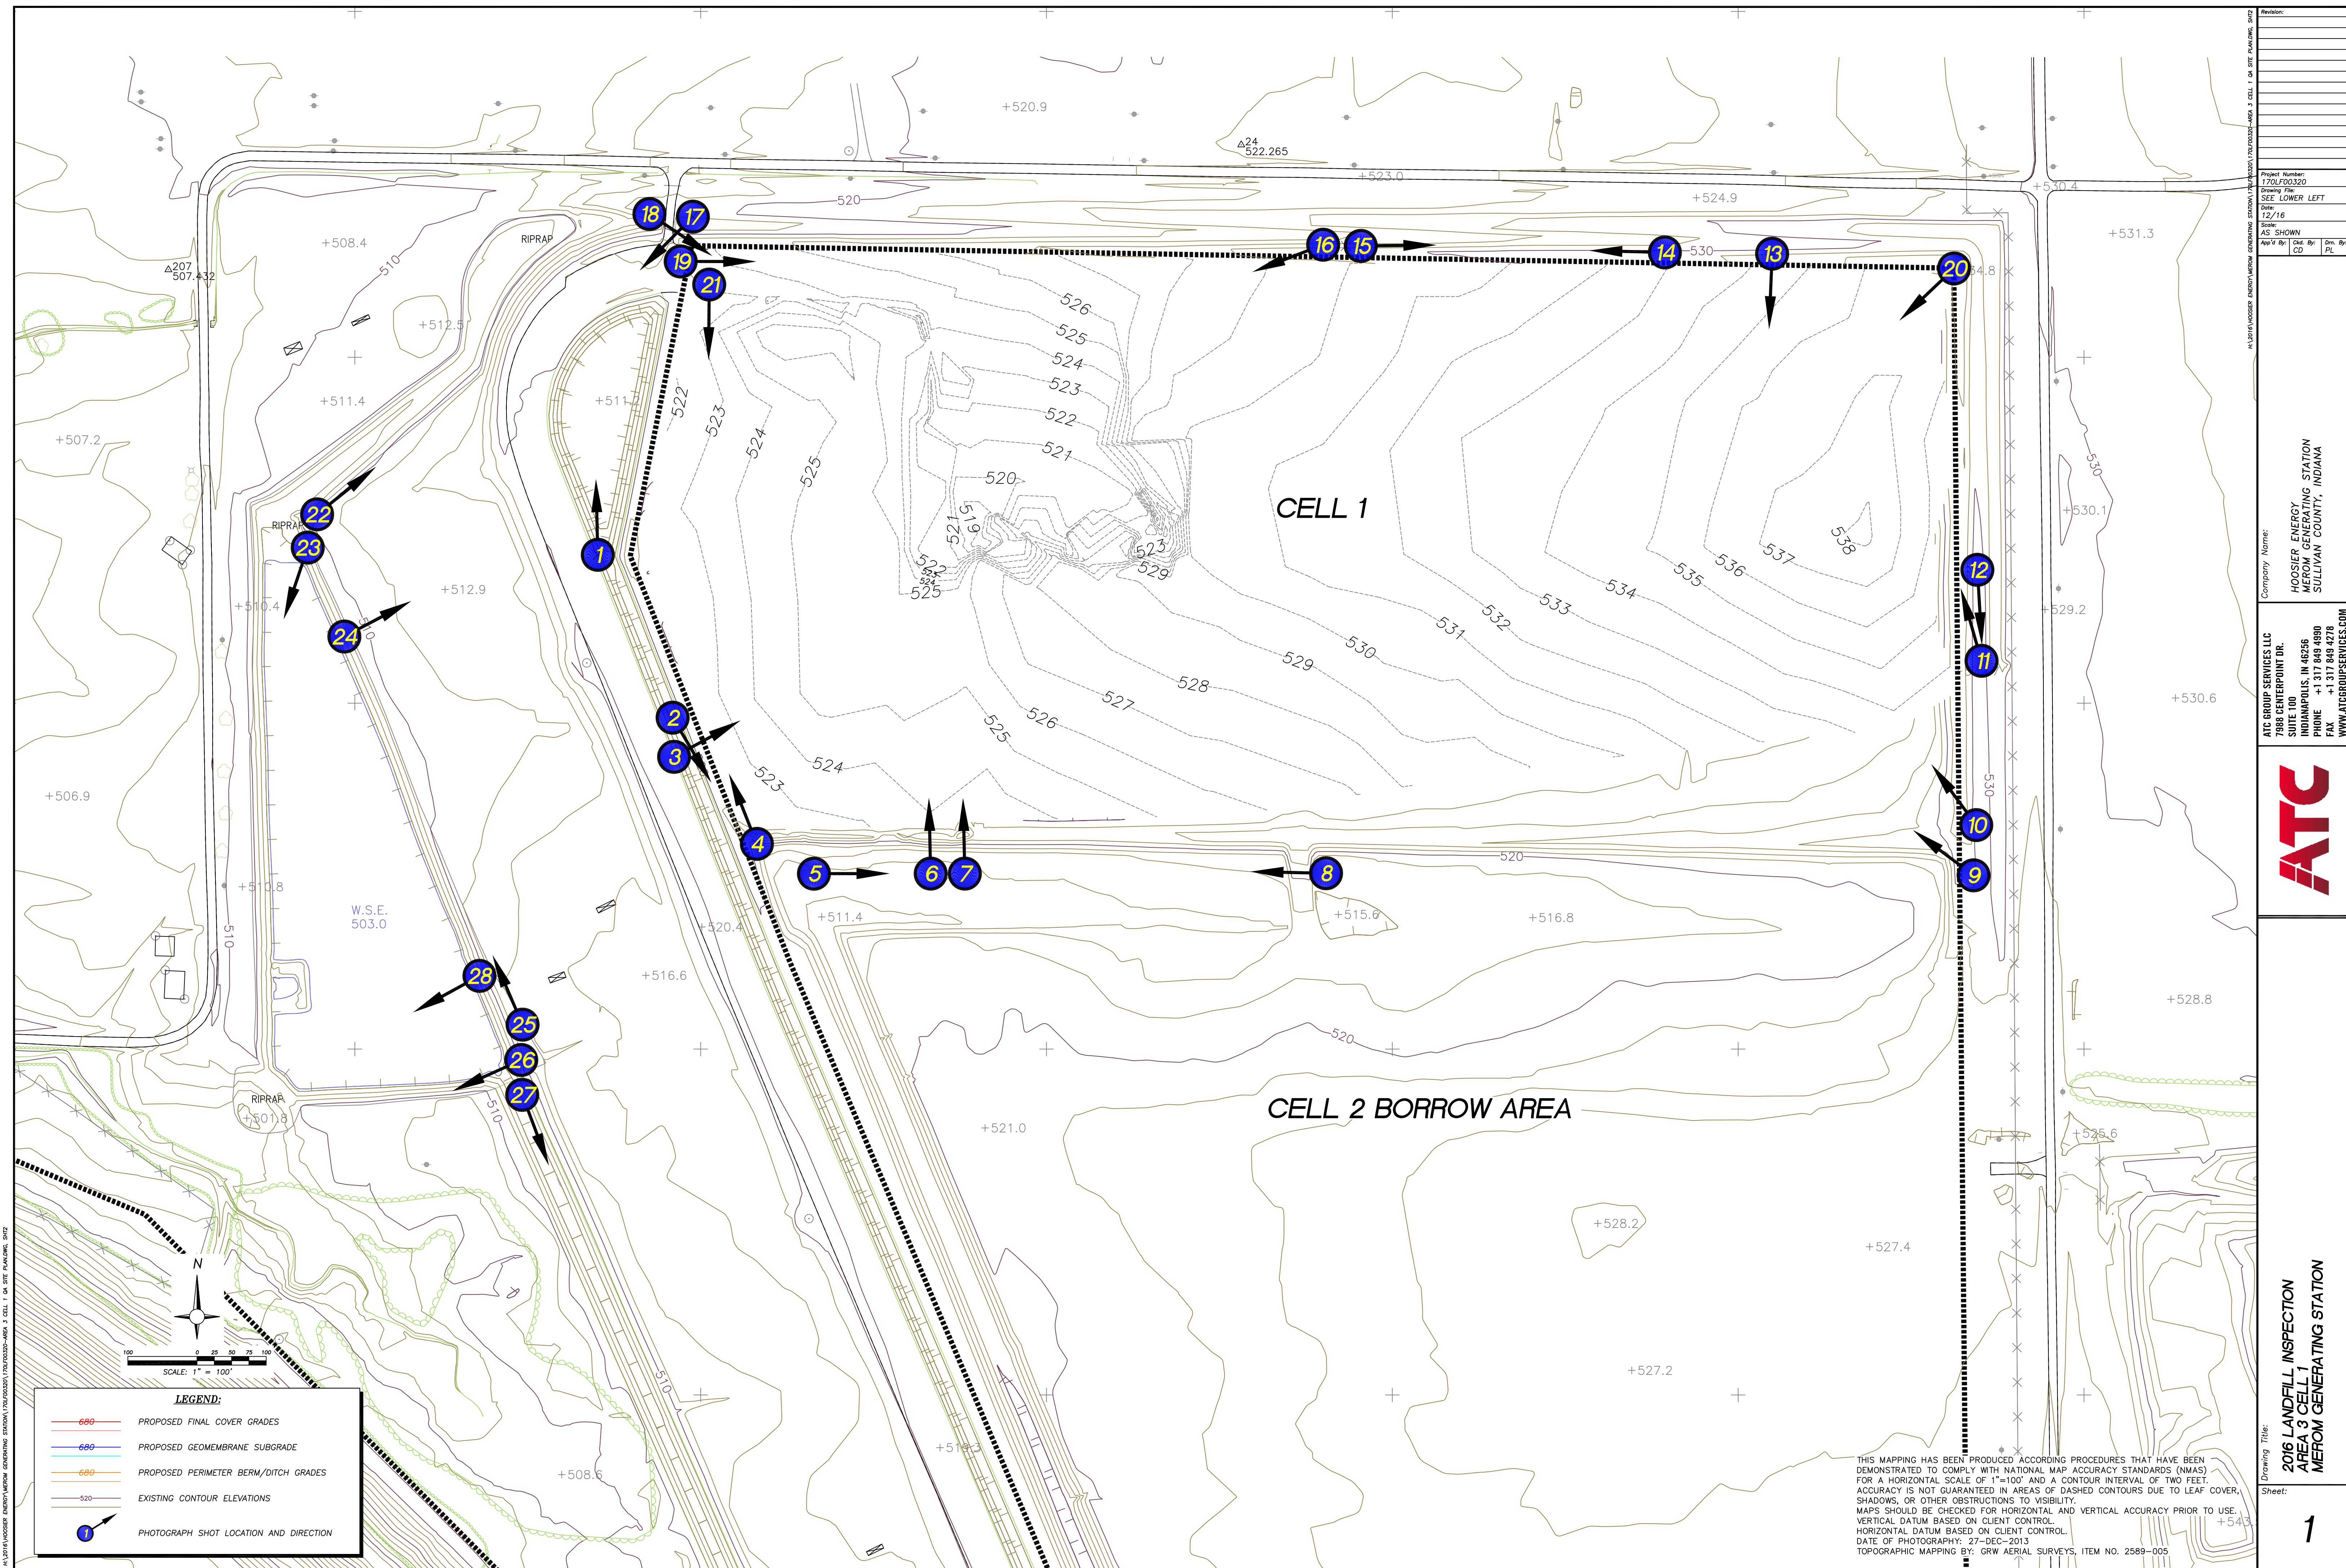
2016 LANDFILL INSPECTION AREA 3 CELL 1 MEROM GENERATING STATION				Drawing Title:
<div style="font-size: 48px; font-weight: bold; margin: 0;">1</div>				Sheet:

- 1) Location 1 encountered the sediment trap basin. The basin appears to be functioning properly to catch runoff from haul roads.

- 2) Locations 2, 3, and 4 encountered soil slopes that are lightly vegetated and have some erosion rills due to surface water runoff.

- 1) Locations 5, 6, 7, and 8 encountered soil slopes that are lightly vegetated with some erosion due to surface water runoff. Location 6 has a small area of exposed geosynthetic liner material.

- 2) Location 9 encountered entrance / exit haul road. The road is a dirt road.

- 1) Locations 10, 11 and 12 encountered soil slopes that are well graded intermediate soil cover with light vegetation at the toe. These slopes have some erosion rills due to surface water runoff.

- 1) Locations 13, 14, 15, and 16 encountered lightly vegetated soil slopes with some erosion rills due to surface water runoff.

- 2) Location 18 encountered an area where water has eroded a drainage ditch.

- 1) Location 20 encountered some areas where Pozotec could be eroded by wind.

- 2) Location 21 encountered areas of gully erosion in Pozotec material.
Recommendation: Regrade CCR to diminish erosion.

- 1) Locations 22 and 23 encountered the riprap channel leading to the sedimentation basin. The riprap is in good shape.
Recommendation: None at this time.
- 2) Location 24 encountered areas of erosion at the top edge of the riprap cover along the east embankment slope of the sedimentation basin.
Recommendation: Regrade and seed along top edge of basin.
- 3) Location 25 encountered the east embankment of the sedimentation basin. The slope appears stable.
Recommendation: None at this time.
- 4) Location 26 and 27 encountered the south concrete lined ditch entrance to the sedimentation basin. Small debris accumulation and vegetation growth in the channel.
Recommendation: None at this time.
- 5) Location 28 encountered the drop inlet of the sediment pond. The inlet appears to be functioning properly with no blockages around the trash guard.
Recommendation: None at this time.

Recommendation: Continue a regular maintenance program to clean out and remove sediment from the trap basin so that it does not become full.

Recommendation: Regrade and overseed the areas where erosion rills are present.

Recommendation: Consider adding course aggregate to entrance and exit haul roads.

Recommendation: This section of drainage ditch should be regraded, protected with riprap, and revegetated.

Recommendation: Flatten the CCR stockpile sideslopes.
