**VISUAL SITE INSPECTION REPORT – 2017**

HOOSIER ENERGY REC  
MEROM GENERATING STATION  
AREA 3 RESTRICTED WASTE LANDFILL  
MEROM, INDIANA

ATC PROJECT NO. 170LF00459

FEBRUARY 7, 2018

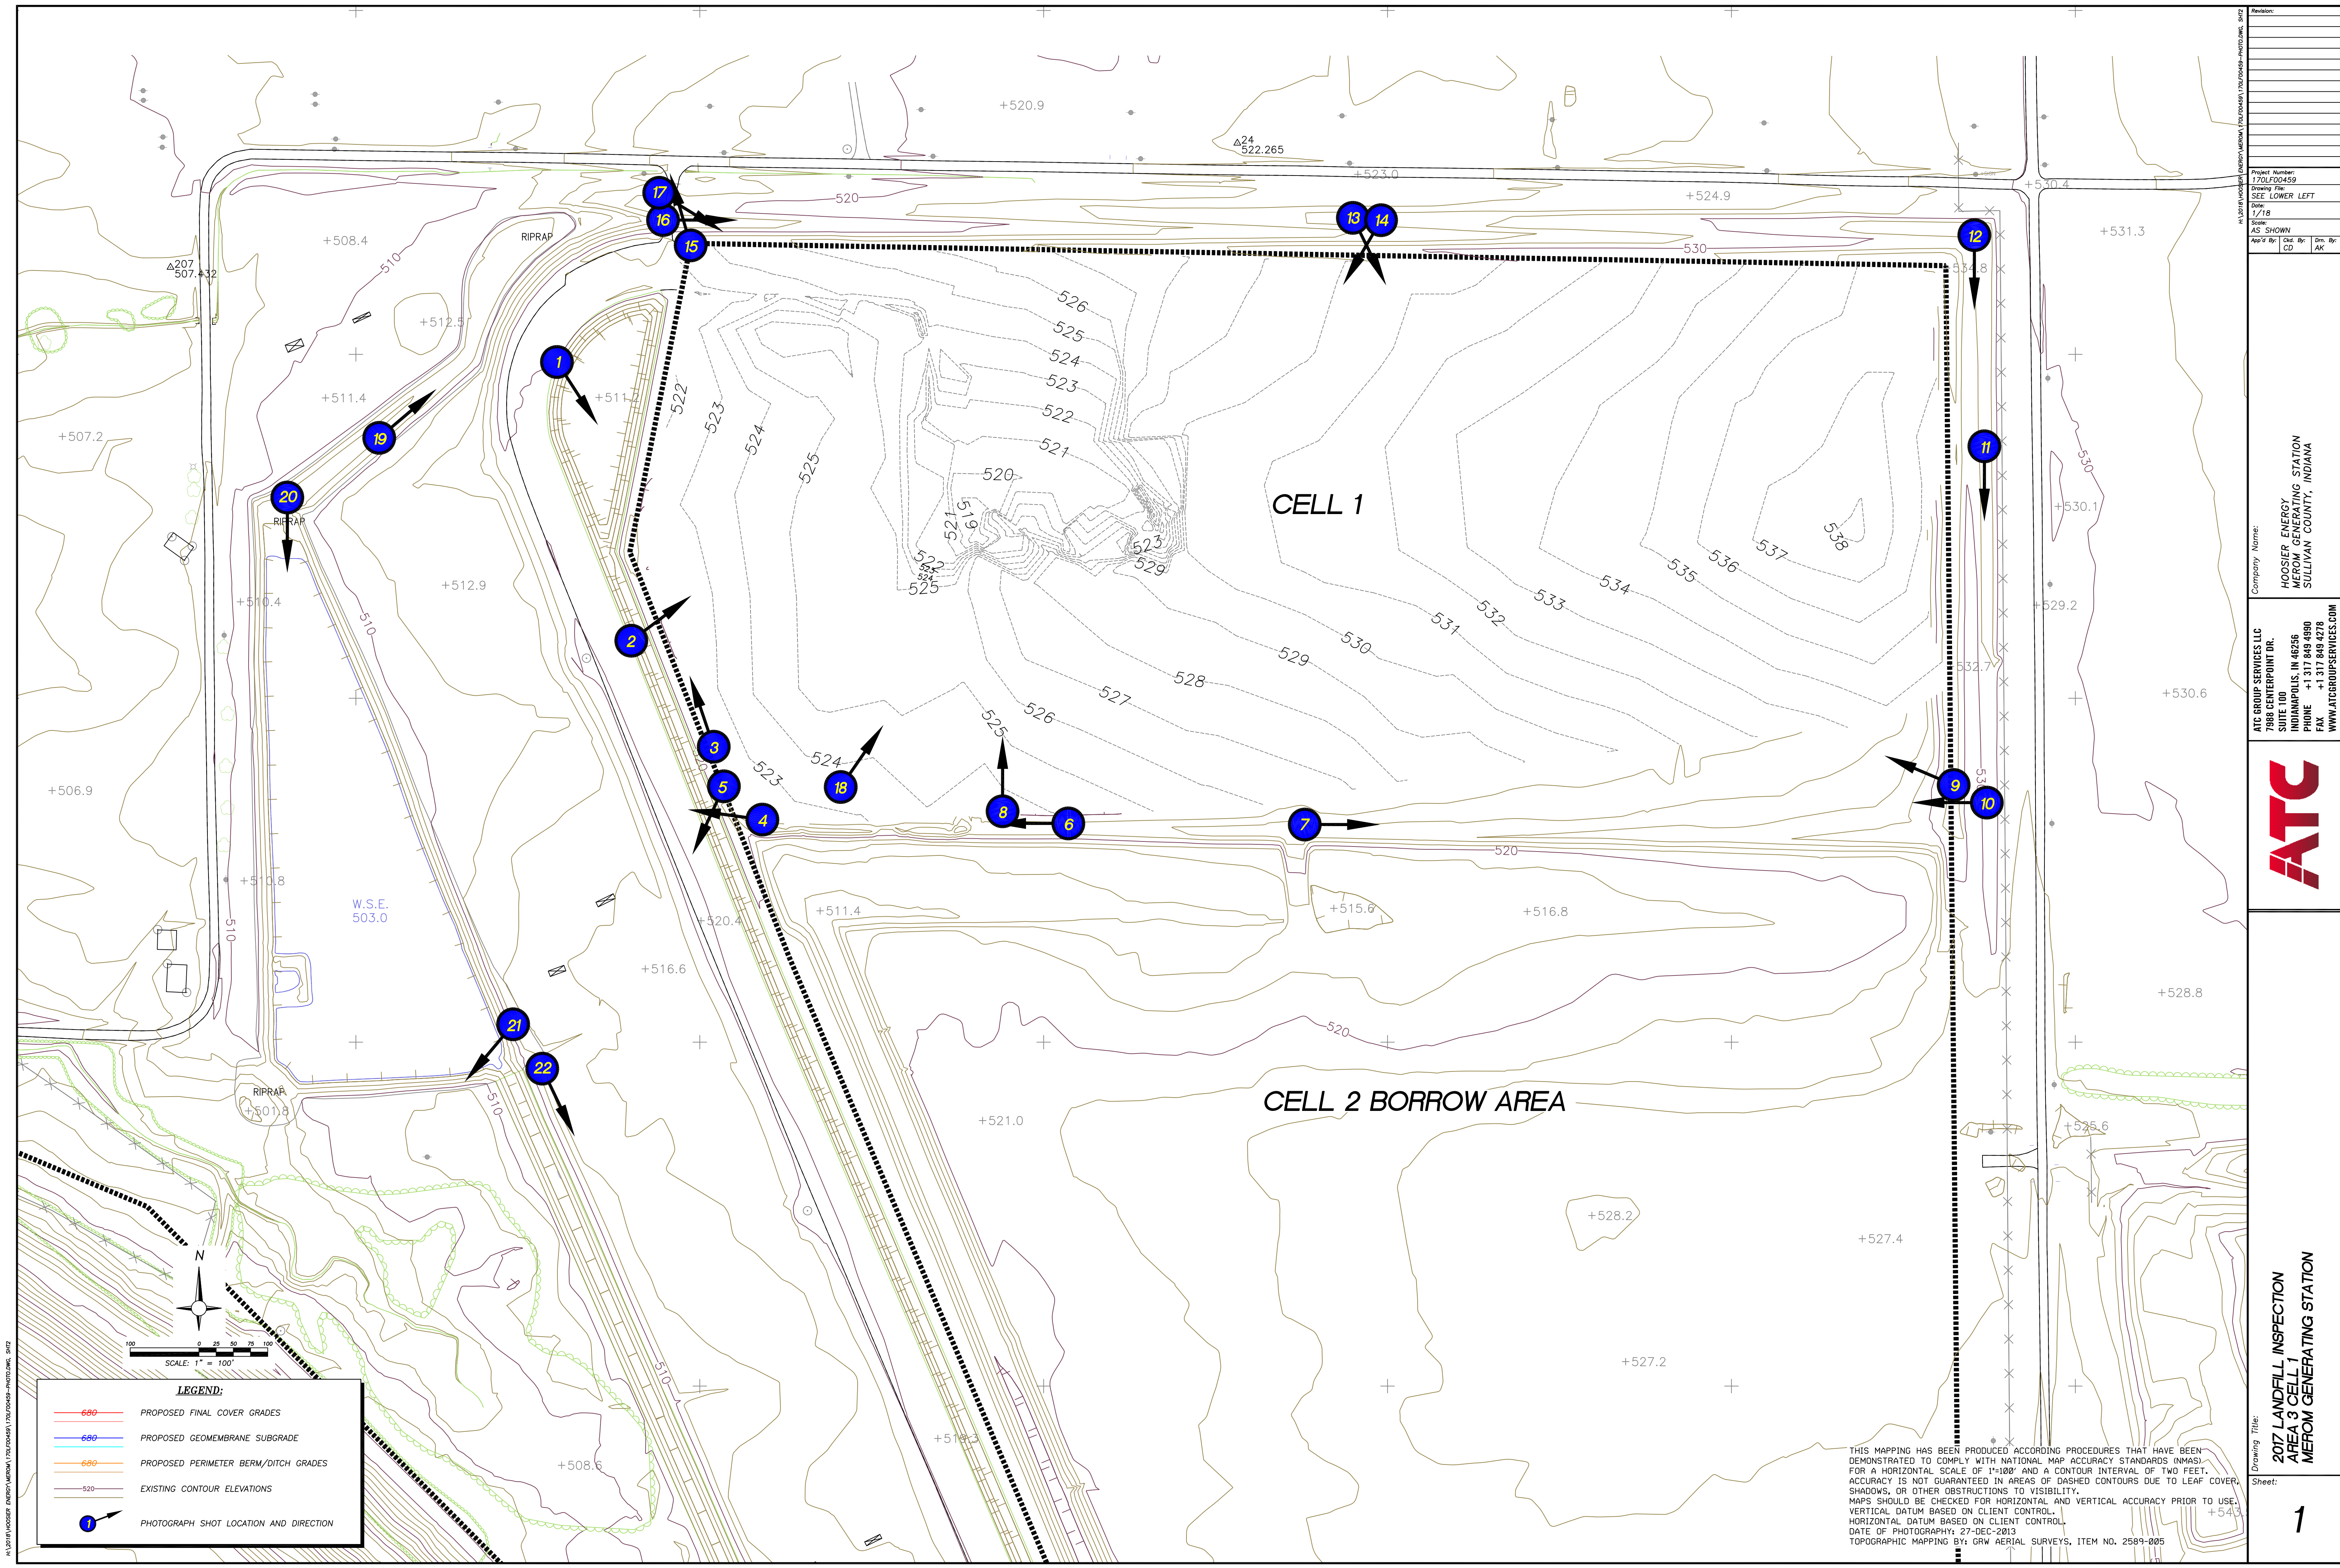
- 1) Location 1 encountered the sediment trap basin. The basin appears to be functioning properly to catch runoff from haul roads. A gravel filter dike has been constructed around the inlet to prevent sediment clogging.  
**Recommendation: Continue a regular maintenance program to clean out and remove sediment from the trap basin so that it does not become full.**
- 2) Location 2 encountered the perimeter concrete lined ditch. Approximately one (1) inch of CCR material has accumulated inside the lined ditch from the adjacent haul road.  
**Recommendation: Continue to clean out the ditch as needed to prevent blockages and maintain capacity.**

- 3) Locations 2 and 3 encountered the perimeter soil berm which is well vegetated.  
**Recommendation: None at this time.**
- 4) Location 3 encountered the interior drainage swale at the toe of slope. CCR material is well compacted and sloped to drain.  
**Recommendation: None at this time.**
- 5) Locations 4 and 5 encountered the southwest corner surface water culvert which collects water from the west and south interior drainage swales of Cell 1.  
**Recommendation: Continue to monitor the culvert entrance to prevent CCR material from escaping the Solid Waste Boundary.**

- 1) Location 6 encountered the soil phase separation berm which separates Cell 1 from (future development) Cell 2. The berm has adequate freeboard.  
**Recommendation: None at this time.**
- 2) Location 7 encountered the south drainage swale. The swale is well compacted and sloped to drain.  
**Recommendation: None at this time.**
- 3) Locations 6, 7, 8 and 9 encountered the south side slope. The slope is well compacted and transitions to vegetated cover at the southeast corner.  
**Recommendation: None at this time.**

The east slope was recently reseeded in 2017 and cover condition improved to reduce rill erosion. Items noted during the visual inspection of this area are described in the following list.

- 1) Locations 11 and 12 encountered side slopes that are well graded with intermediate soil cover and good vegetation along the face.  
**Recommendation: None at this time.**

Previous erosion features in the perimeter ditch along the northwest corner of the landfill, noted during the 2016 inspection, have been repaired in 2017. Additional riprap has been added near culvert inverts at the stream crossing. Items noted during the visual inspection of this area are described in the following list.

- 1) Locations 13 and 14 encountered well vegetated soil slopes.  
**Recommendation: None at this time.**

- 1) Location 17 encountered a haul road to the top of the landfill along the south side. The haul road is well compacted and stockpiles have been flattened to prevent wind erosion.  
**Recommendation: None at this time.**
- 2) Location 18 encountered areas of gully erosion in the Pozotec material at the northwest corner of the landfill.  
**Recommendation: Regrade and compact CCR as needed to diminish erosion and continue to maintain perimeter soil berms to contain CCR inside the Solid Waste Boundary.**

- 1) Location 19 encountered the riprap channel leading to the sedimentation basin. The riprap is in good shape.  
**Recommendation: None at this time.**
- 2) Location 20 encountered the west sedimentation basin and riprap bank slopes.  
**Recommendation: None at this time.**
- 3) Location 21 encountered the south entrance of the sediment pond.  
**Recommendation: None at this time.**
- 4) Location 22 encountered the south concrete lined ditch entrance to the sedimentation basin. Small debris accumulation in the channel.  
**Recommendation: Continue to clean out the ditch as needed to prevent blockages and maintain capacity.**
