VISUAL SITE INSPECTION REPORT – 2020

HOOSIER ENERGY
RURAL ELECTRIC COOPERATIVE, INC.
MEROM GENERATING STATION
AREA 3 RESTRICTED WASTE LANDFILL
MEROM, INDIANA

ATC PROJECT NO. 170LF00788

JANUARY 15, 2021

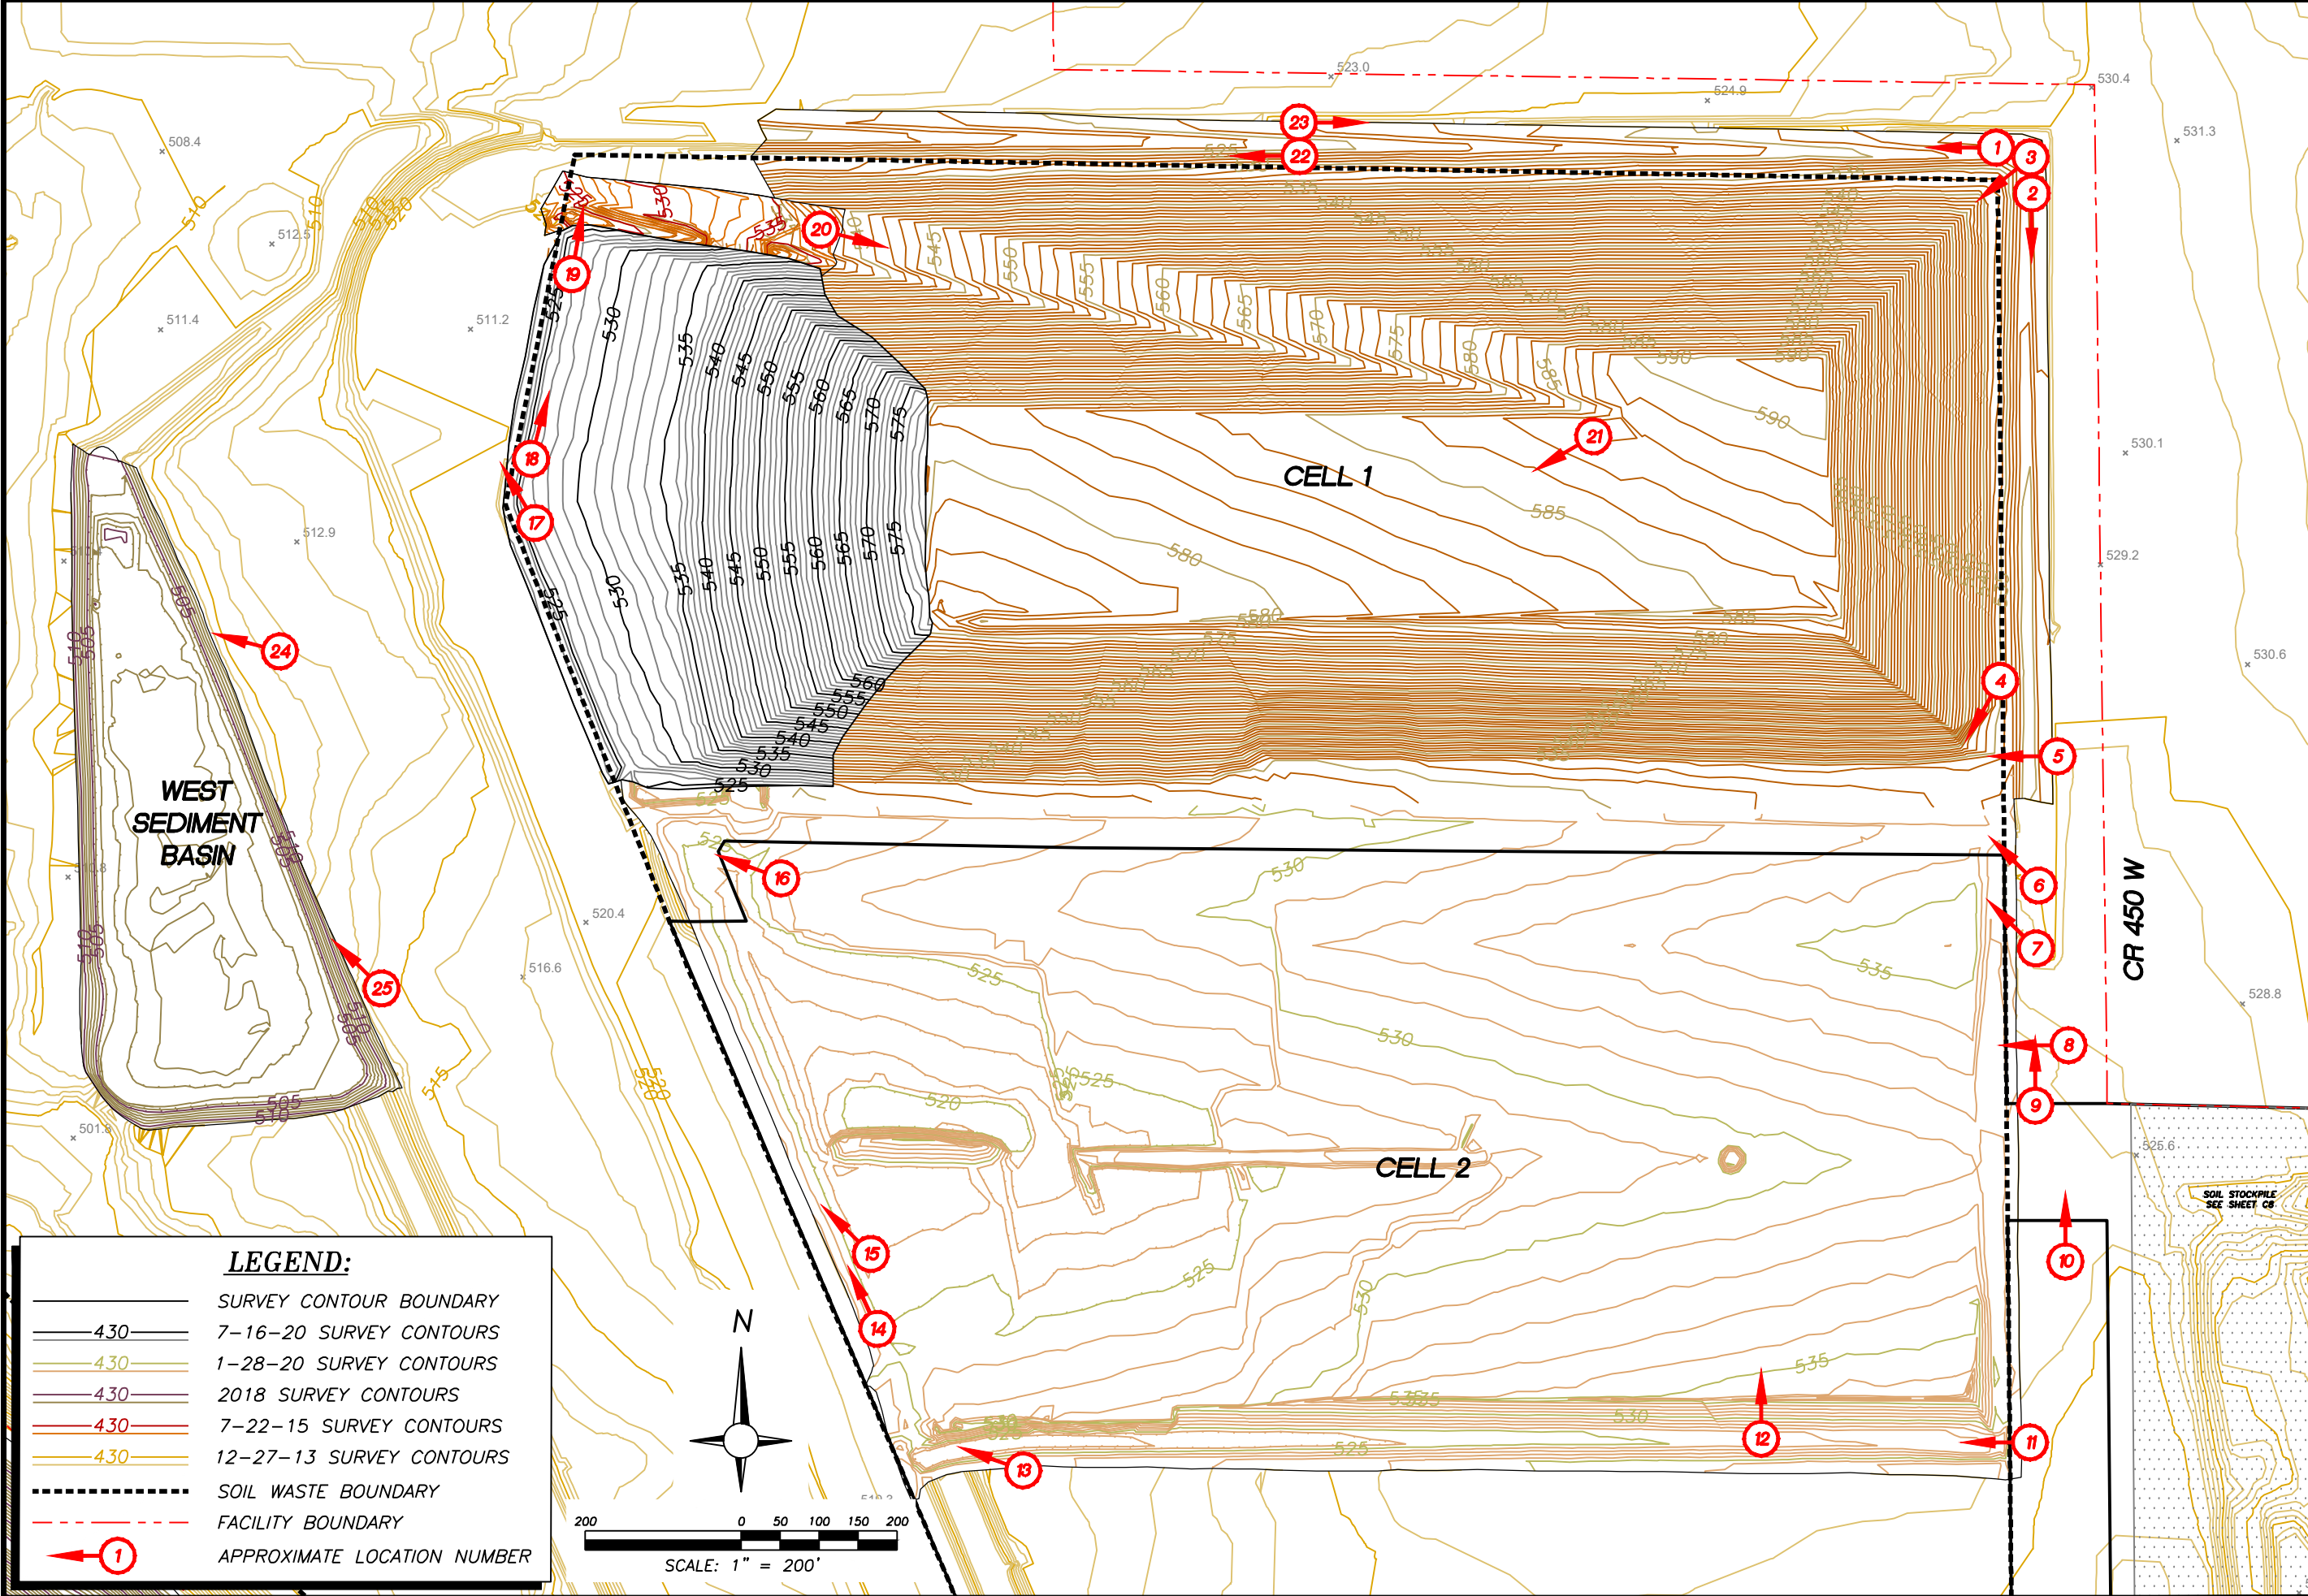
OBSERVATION LOCATION PLAN
AREA 3 RESTRICTED WASTE LANDFILL
2020 INSPECTION
HOOSIER ENERGY
MEROM GENERATING STATION

- 1) The north and east exterior slopes and the top of Cell 1 are generally well graded with established and maintained vegetation as observed at Locations 1 – 3 and 21 – 23.

- 2) At Location 4 near the southeast corner of Cell 1 the inspection noted sparse vegetation on the exterior slope of Cell 1.

- 3) At Locations 5, 7, 8 and 10 on the east side of Cell 2 the inspection noted sparse vegetation on the temporary cover placed on the exterior slope of Cell 2 that is contributing to rill erosion and equipment ruts in the perimeter ditch.

- 4) At Locations 6, 11, and 14 around the perimeter of Cell 2 the inspection noted that contact stormwater runoff is contained within Cell 2.

- 5) As noted at Location 9 on the east side of Cell 2 the inspection noted sparse vegetation on the perimeter road near the monitoring wells.

- 6) At Location 12 on the south side of Cell 2 the inspection noted several large erosion rills on the inside and outside of the Cell 2 south perimeter berm.

- 7) At Location 13 at the southwest corner of Cell 2 the inspection noted a riprap check dam installed upstream of an outlet to the concrete lined perimeter ditch.

- 8) At Locations 15 along the west side of Cell 2, the inspection noted that sediment deposits in the concrete lined ditch are maintained at acceptable levels.

- 9) At Locations 16 near the northwest corner of Cell 2, the inspection noted a large amount of sediment buildup behind a riprap check dam upstream of an outlet to the concrete lined ditch.

- 10) At Locations 17 near the northwest corner of Cell 1, the inspection noted that the sediment levels in the concrete lined pond are maintained at acceptable levels.

- 11) At Locations 18 near the northwest corner of Cell 1, the inspection noted sparse vegetation west of the concrete lined pond that could be susceptible to erosion.

- 12) At Locations 19 near the northwest corner of Cell 1, the inspection noted erosion from a small drainage swale at the toe of the slope that begins at the end of the installed erosion control matting and continues to the riprap lined channel below.

- 13) At Locations 20 on the north side of Cell 1 the inspection noted sparse vegetation and minor erosion at the toe of the recently added diversion berms across the haul road to the top of Cell 1. It should be noted that the erosion is much less than that noted in 2019.

- 1) At Location 24 on the east slope of the West Sediment Basin west of Cell 1 the inspection noted a large erosion rill at the crest of the pond.

- 2) At Location 25 on the east slope of the West Sediment Basin west of Cell 1 the inspection noted that the pond is generally in good condition and maintaining adequate freeboard.

Recommendation: Monitor vegetation growth and reseed as necessary.

Recommendation: Fill the erosion rills, repair the equipment ruts, and reseed as needed to prevent further erosion. Consider armoring a cross section of the channel to allow better equipment access inside the perimeter ditch.

Recommendation: Reseed as necessary to establish vegetation however, it may be difficult in high traffic areas. If vegetation growth does not establish, consider adding a gravel layer to the perimeter road in high traffic areas to prevent erosion.

Recommendation: Fill the erosion and reseed as needed to prevent further erosion.

Recommendation: Remove the accumulated sediments to maintain capacity of the channel.

Recommendation: Monitor the vegetation growth and reseed as necessary to establish adequate cover.

Recommendation: Armor the section of slope between the erosion control matting and the riprap.

Recommendation: Fill the erosion and reseed as needed to prevent further erosion. Consider adding temporary erosion control matting to the toe of the diversion berms to allow vegetation growth to establish.

Recommendation: Fill the erosion and reseed as needed to prevent further erosion. Consider adding armoring if the erosion persists.
