VISUAL SITE INSPECTION REPORT – 2021

HOOSIER ENERGY
RURAL ELECTRIC COOPERATIVE, INC.
MEROM GENERATING STATION
AREA 3 RESTRICTED WASTE LANDFILL
MEROM, INDIANA

ATC PROJECT NO. 170LF01152

OCTOBER 21, 2021

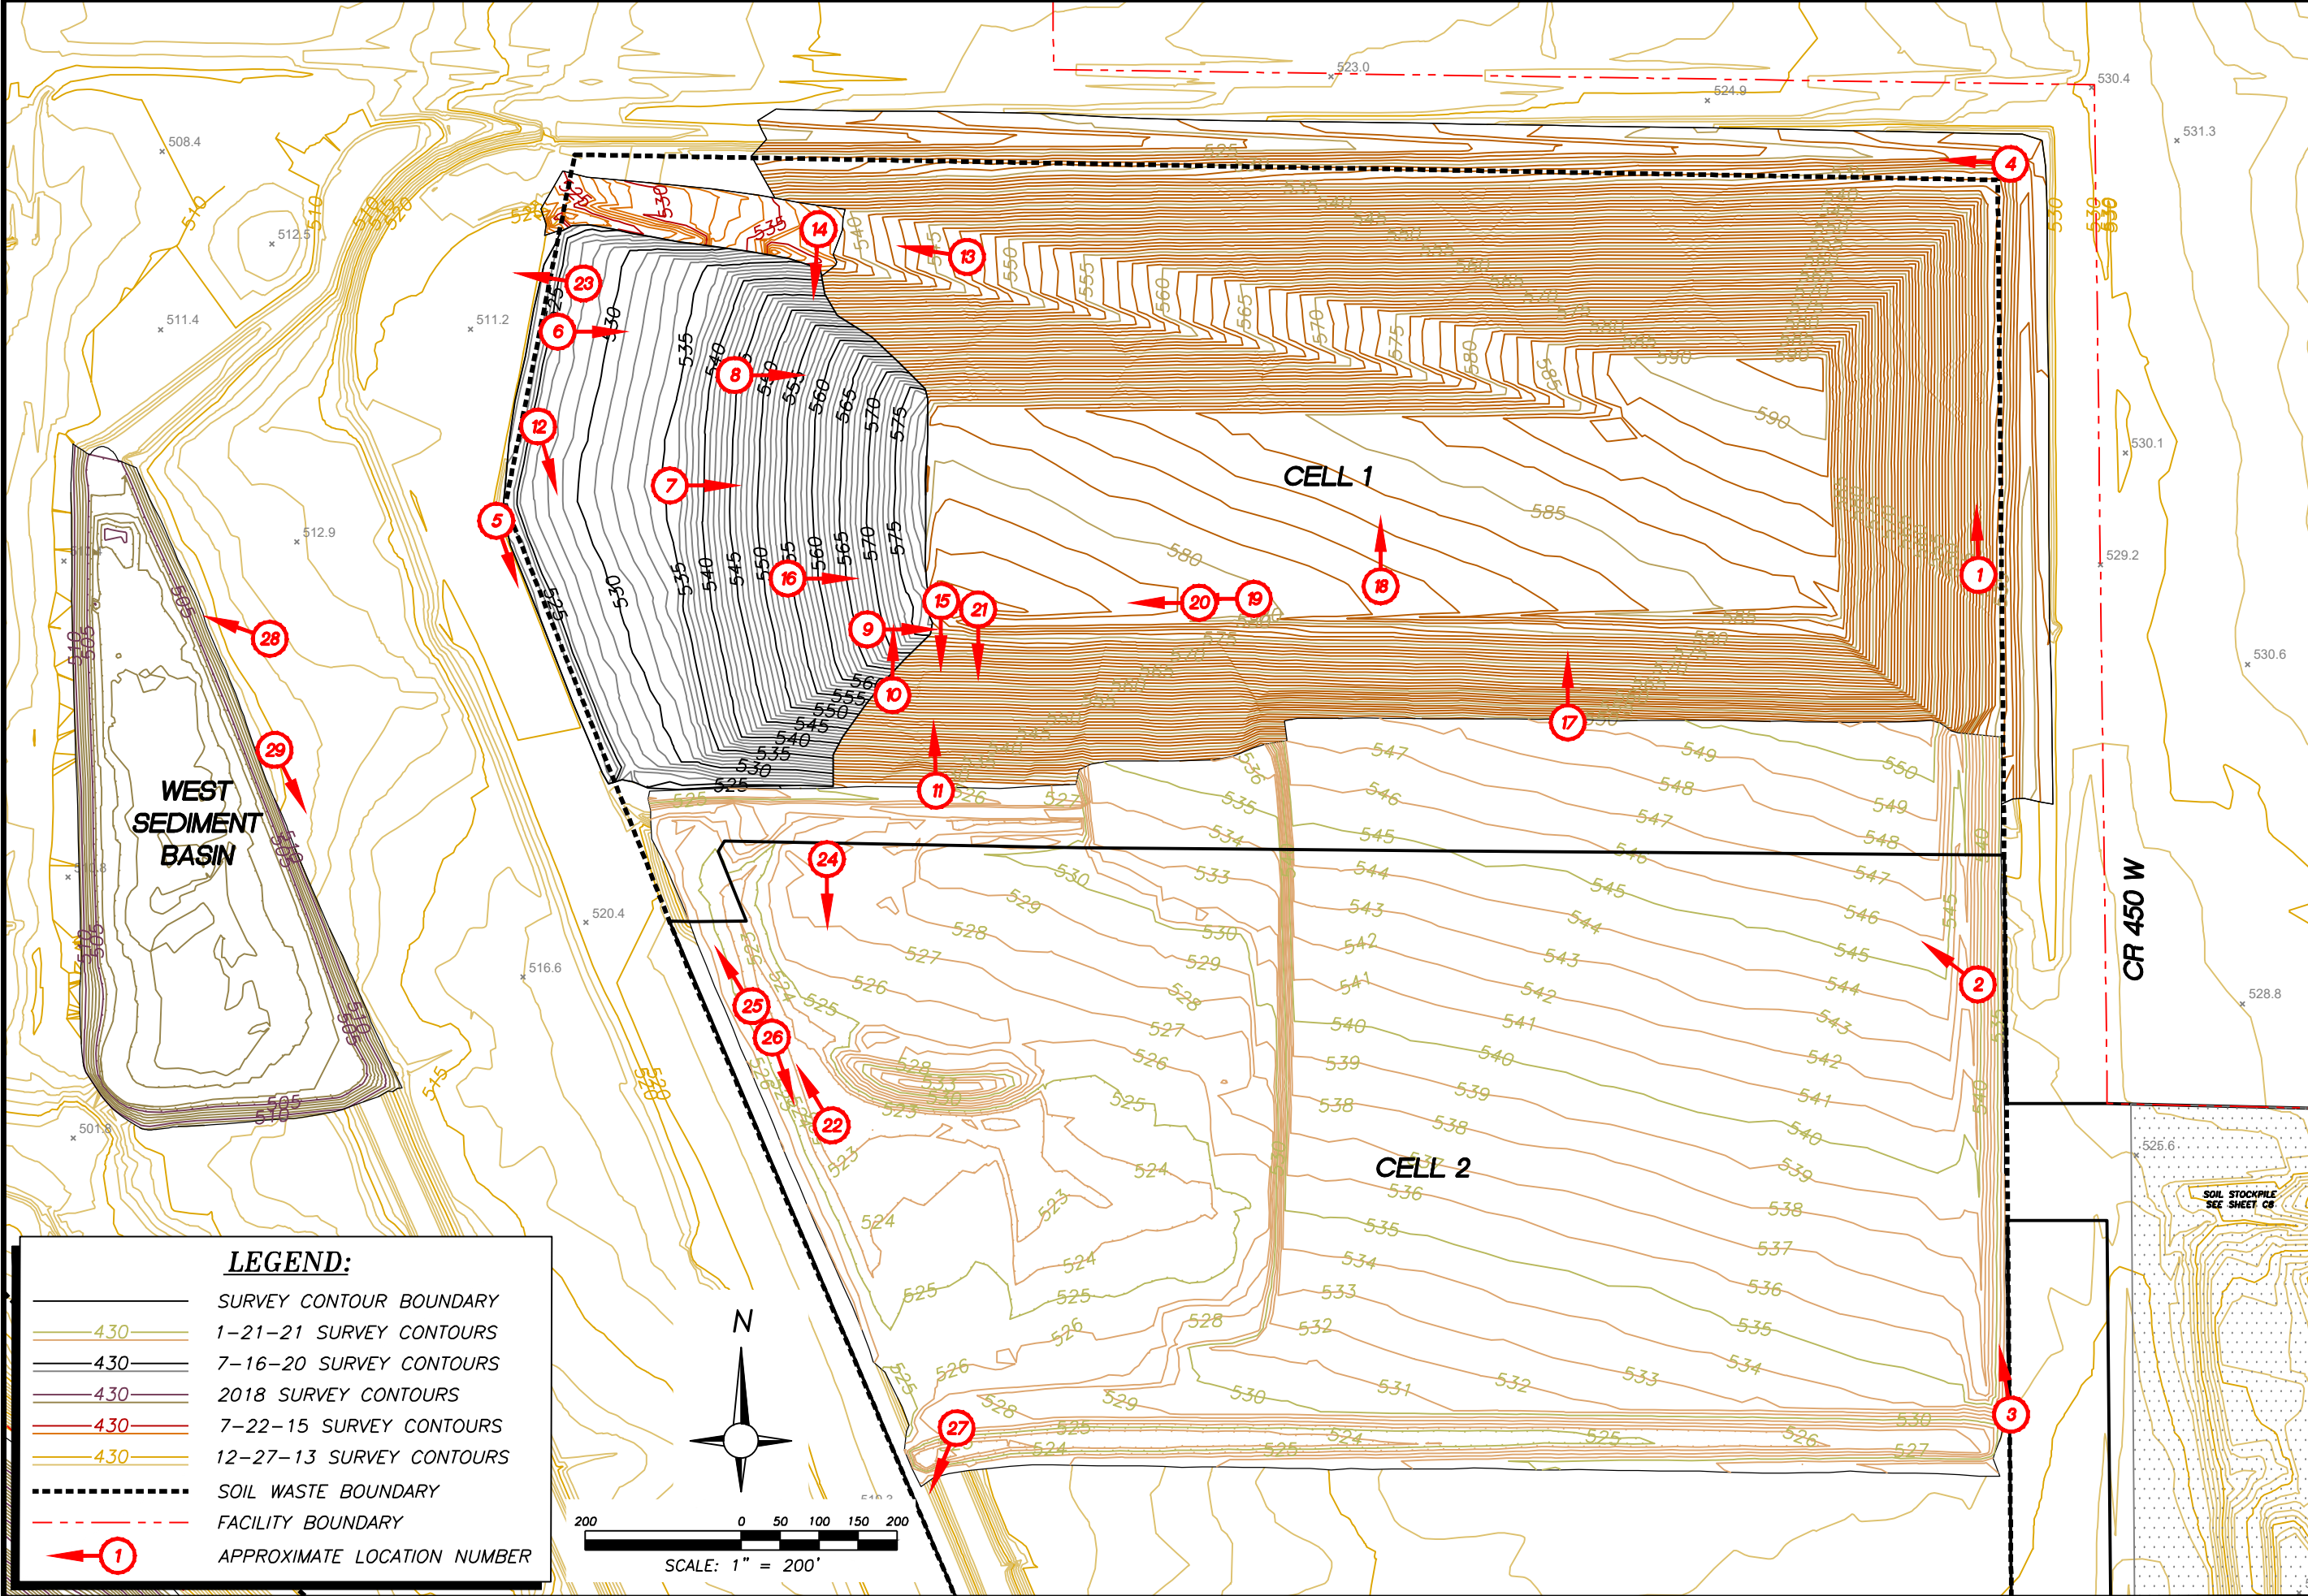
Drn. By:	BH	Ckd. By:	MT	App'd By:		ATC
Project Number:	170LF01152	Drawing File:	SEE LOWER LEFT			
OBSERVATION LOCATION PLAN						
AREA 3 RESTRICTED WASTE LANDFILL						
2021 INSPECTION						
HOOSIER ENERGY						
MEROM GENERATING STATION						
Date:	10/2021	Scale:	AS SHOWN	Figure:	2

- 1) The north and east exterior slopes of Cell 1 and the east exterior slope of Cell 2 are generally well graded with established and maintained vegetation as observed at Locations 1, 3 and 4.

- 2) At Location 2 near the northeast corner of Cell 2 the inspection noted sparse vegetation on the exterior slope of Cell 2.

- 3) At Location 5 along perimeter concrete ditch on the west side of Cell 1 the inspection noted minor amount of sediments on the concrete lined ditch, it is still within acceptable levels.

- 4) At Locations 6, 7, 8, 9, and 16 on the west side of Cell 1 the inspection noted sparse vegetation on the intermediate cover placed on the exterior slope of Cell 1 that is contributing to rill erosion.

- 5) At Locations 10, 11, and 17, on the south side of Cell 1, the inspection noted sparse vegetation on the intermediate cover placed on the exterior slope of Cell 1 that is contributing to rill erosion.

- 6) At Locations 12 and 22, on the west sides of Cell 1 and Cell 2 respectively, the inspection noted sparse vegetation on the exterior slope.

- 7) As indicated at Locations 13 and 14, at the access ramp on the north side of Cell 1, the inspection noted sparse vegetation that is contributing to rill erosion.

- 8) At Location 15 on the top corner of the southeast side of Cell 1, the inspection noted overgrown vegetation at entrance to down drain pipe.

- 9) At Locations 18, 19, and 20 on the top section of Cell 1 the inspection noted sparse vegetation on the intermediate cover that is contributing to rill erosion.

- 10) At Location 23 along the northwest side of Cell 1, the inspection noted accumulated sediment deposits on the north side of concrete lined pond.

- 11) At Locations 24, view of CCR material placement on the southwest side of Cell 2, no issues observed.

- 12) At Locations 25 and 26 along the west side of Cell 2, the inspection noted accumulated CCR material on that section of the perimeter concrete ditch.

- 13) At Location 27 entrance driveway culvert on the southwest corner of active Cell 2, the inspection noted there is sediment accumulation on the upstream of the pipe. The pipe is functioning properly as the sediments do not impeding drainage flows.

- 1) At Locations 28 and 29 on the east side of the West Sediment Basin the inspection noted that the pond is generally in good condition and maintaining adequate freeboard.

Recommendation: Monitor vegetation growth and reseed as necessary.

Recommendation: Fill the erosion rills, and reseed as needed to prevent further erosion.

Recommendation: Reseed as necessary to establish vegetation however, it may be difficult in high traffic areas. If vegetation growth does not establish, consider adding a gravel layer to the access ramp to prevent erosion.

Recommendation: Remove vegetation and place riprap around pipe entrance to facilitate proper drainage.

Recommendation: Remove accumulated sediments.

Recommendation: Remove accumulated CCR sediments and install sediment control measures at the source to help settle out sediment material within Cell 2 and prevent it from spilling over into the concrete ditch.

Recommendation: Monitor sediment accumulation at this time.
