VISUAL SITE INSPECTION REPORT – 2020

HOOSIER ENERGY
RURAL ELECTRIC COOPERATIVE, INC.
MEROM GENERATING STATION
AREA 3 RESTRICTED WASTE LANDFILL
MEROM, INDIANA

ATC PROJECT NO. 170LF00788

JANUARY 15, 2021

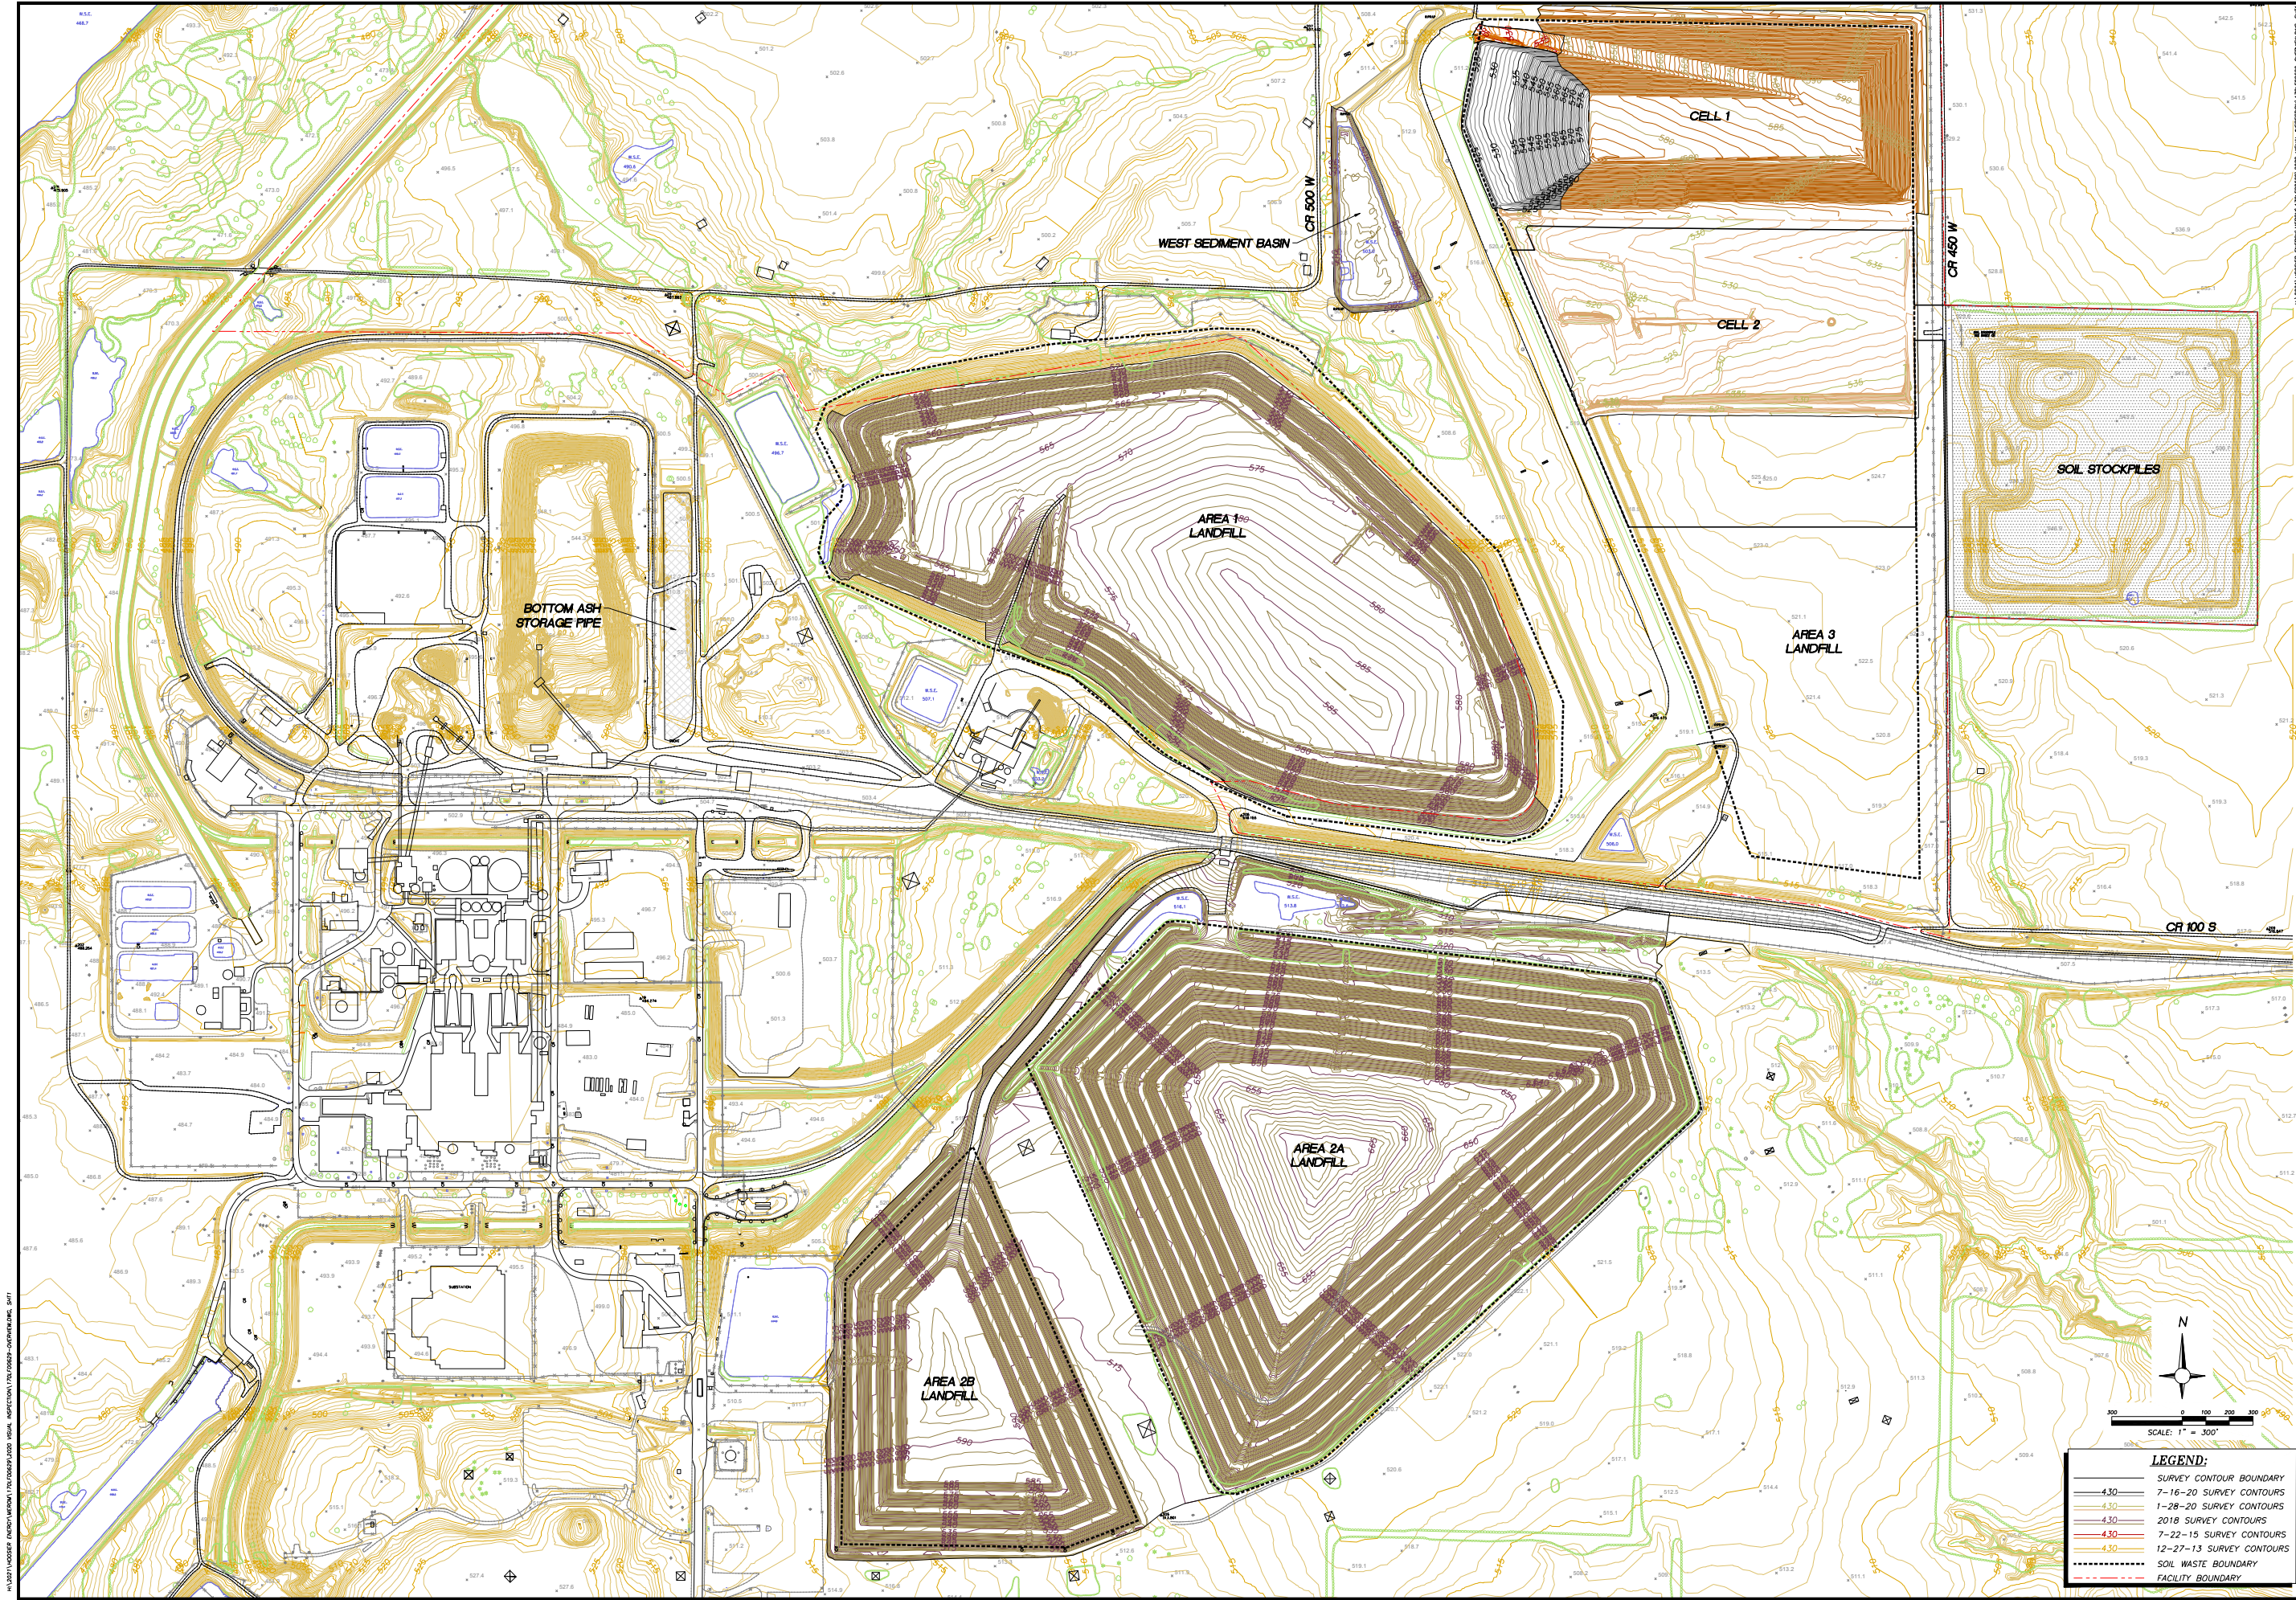
OBSERVATION LOCATION PLAN
AREA 3 RESTRICTED WASTE LANDFILL
2020 INSPECTION
HOOSIER ENERGY
MEROM GENERATING STATION

- 1) The north and east exterior slopes and the top of Cell 1 are generally well graded with established and maintained vegetation as observed at Locations 1 – 3 and 21 – 23.

- 2) At Location 4 near the southeast corner of Cell 1 the inspection noted sparse vegetation on the exterior slope of Cell 1.

- 3) At Locations 5, 7, 8 and 10 on the east side of Cell 2 the inspection noted sparse vegetation on the temporary cover placed on the exterior slope of Cell 2 that is contributing to rill erosion and equipment ruts in the perimeter ditch.

- 4) At Locations 6, 11, and 14 around the perimeter of Cell 2 the inspection noted that contact stormwater runoff is contained within Cell 2.

- 5) As noted at Location 9 on the east side of Cell 2 the inspection noted sparse vegetation on the perimeter road near the monitoring wells.

- 6) At Location 12 on the south side of Cell 2 the inspection noted several large erosion rills on the inside and outside of the Cell 2 south perimeter berm.

- 7) At Location 13 at the southwest corner of Cell 2 the inspection noted a riprap check dam installed upstream of an outlet to the concrete lined perimeter ditch.

Recommendation: Monitor vegetation growth and reseed as necessary.

Recommendation: Fill the erosion rills, repair the equipment ruts, and reseed as needed to prevent further erosion. Consider armoring a cross section of the channel to allow better equipment access inside the perimeter ditch.

Recommendation: Reseed as necessary to establish vegetation however, it may be difficult in high traffic areas. If vegetation growth does not establish, consider adding a gravel layer to the perimeter road in high traffic areas to prevent erosion.

Recommendation: Fill the erosion and reseed as needed to prevent further erosion.
